cooling tower reconstruction

BEST PRACTICES

Values and Pitfalls

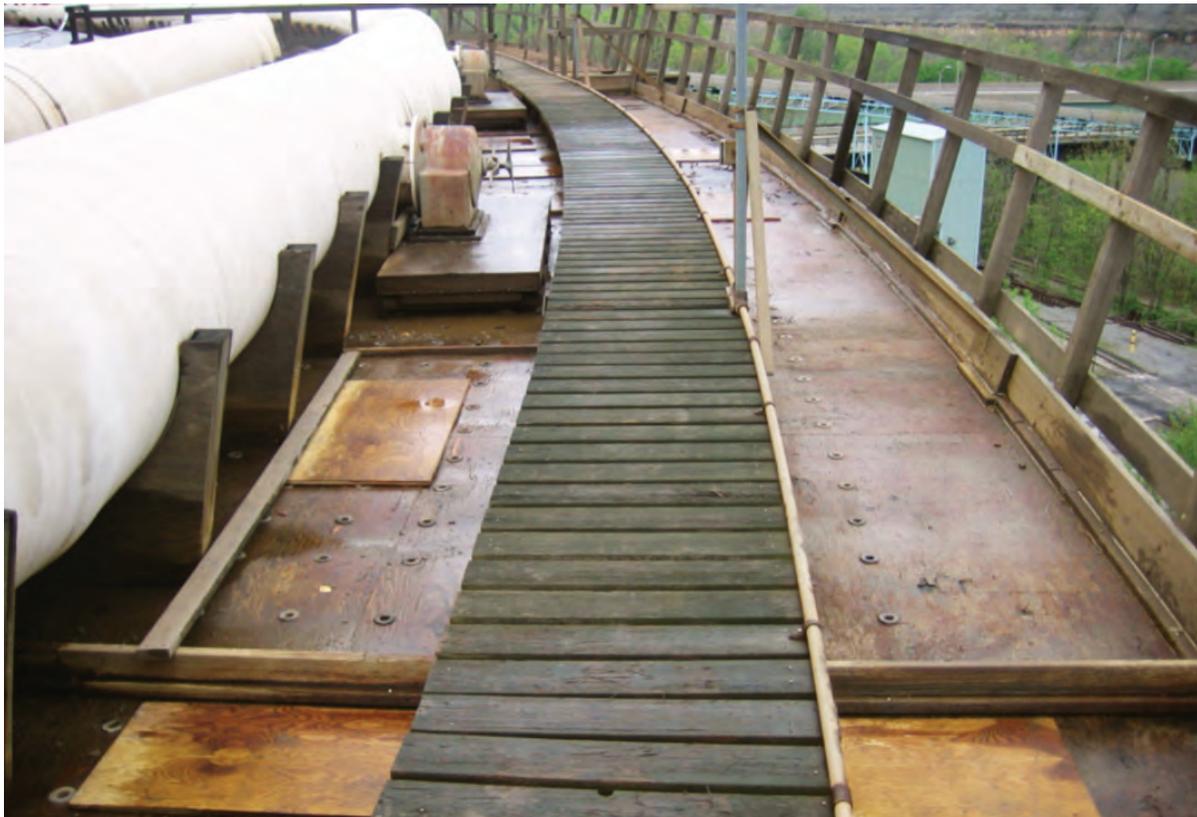
Wood Crossflow Cooling Tower Prior to Reconstruction

Reconstruction also presents an excellent opportunity to upgrade the structural components of the cooling tower. Replacement of wood with FRP (fiberglass reinforced plastic) is an excellent choice when the lifespan of the cooling tower is a top priority. For example, during a reconstruction job to a wood crossflow cooling tower at a coal-powered baseload plant, a customer may choose to make structural upgrades such as:

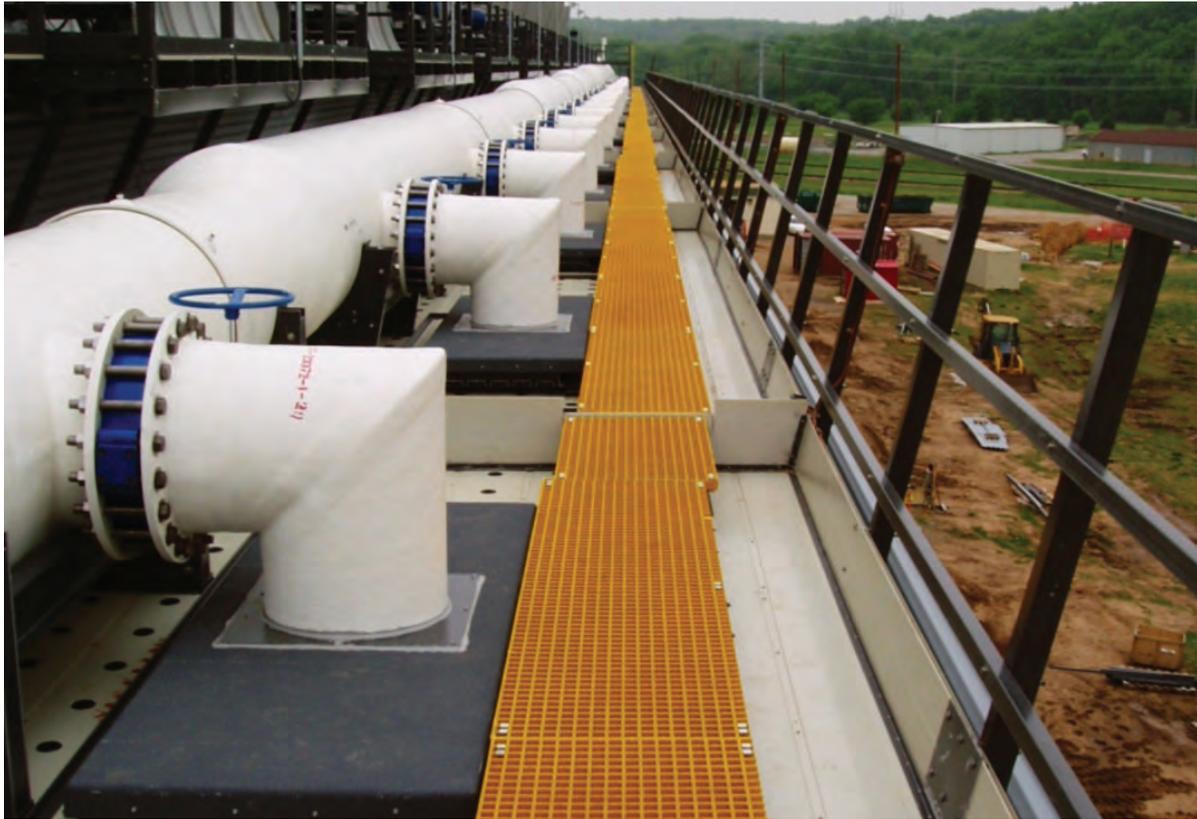
Post-Reconstruction Showing FRP Structural Enhancements

- Hot water deck and deck supports from plywood to FRP
- Girts from wood to FRP
- Steel riser support beam from carbon steel to stainless steel
- Walkways from wood to FRP
- Crossflow pipe saddle supports from wood to FRP (for submerged wet material area)
- Structural splice plates from wood to FRP
